# REHABILITATING STREETS AND BUILDINGS IN NASHUA

A GUIDE FOR  
FACADES,  
STREETS AND  
MORE

CITY OF NASHUA, NH

DOWNTOWN NASHUA

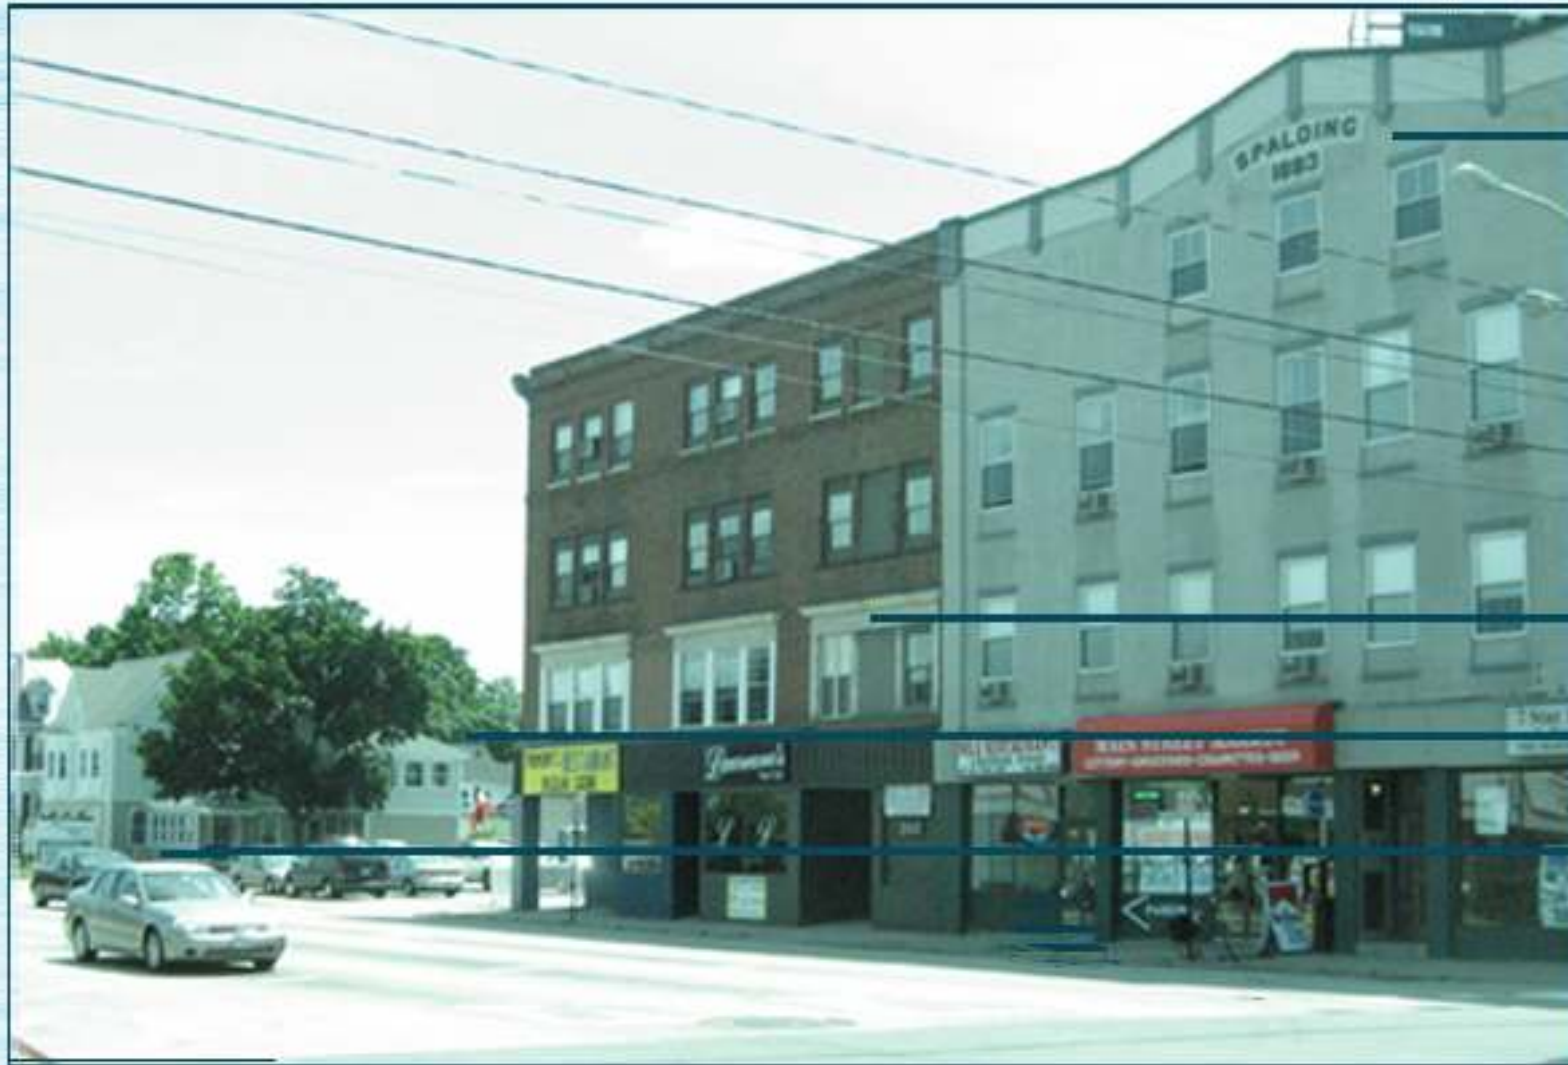
235-255 Main Street

This block, located on Main Street, shows promise of becoming a thriving business area by updating historic storefronts.

- Restore Brick Facade
- Full Length Windows added
- Entablature for signs to go with building
- Inappropriate awning
- Storefront restored

- Full Length Windows added
- Paint to Match Pediment
- Windows should not be filled in
- Entablature for signs of inappropriate material
- Storefront restored

- Shingle style exterior revived
- Restore Palladian window detailing
- Signage improvement
- Inappropriate colonial windows, restore recessed window detail
- Inappropriate doors
- Bay windows restored
- Should have brown wooden shingles

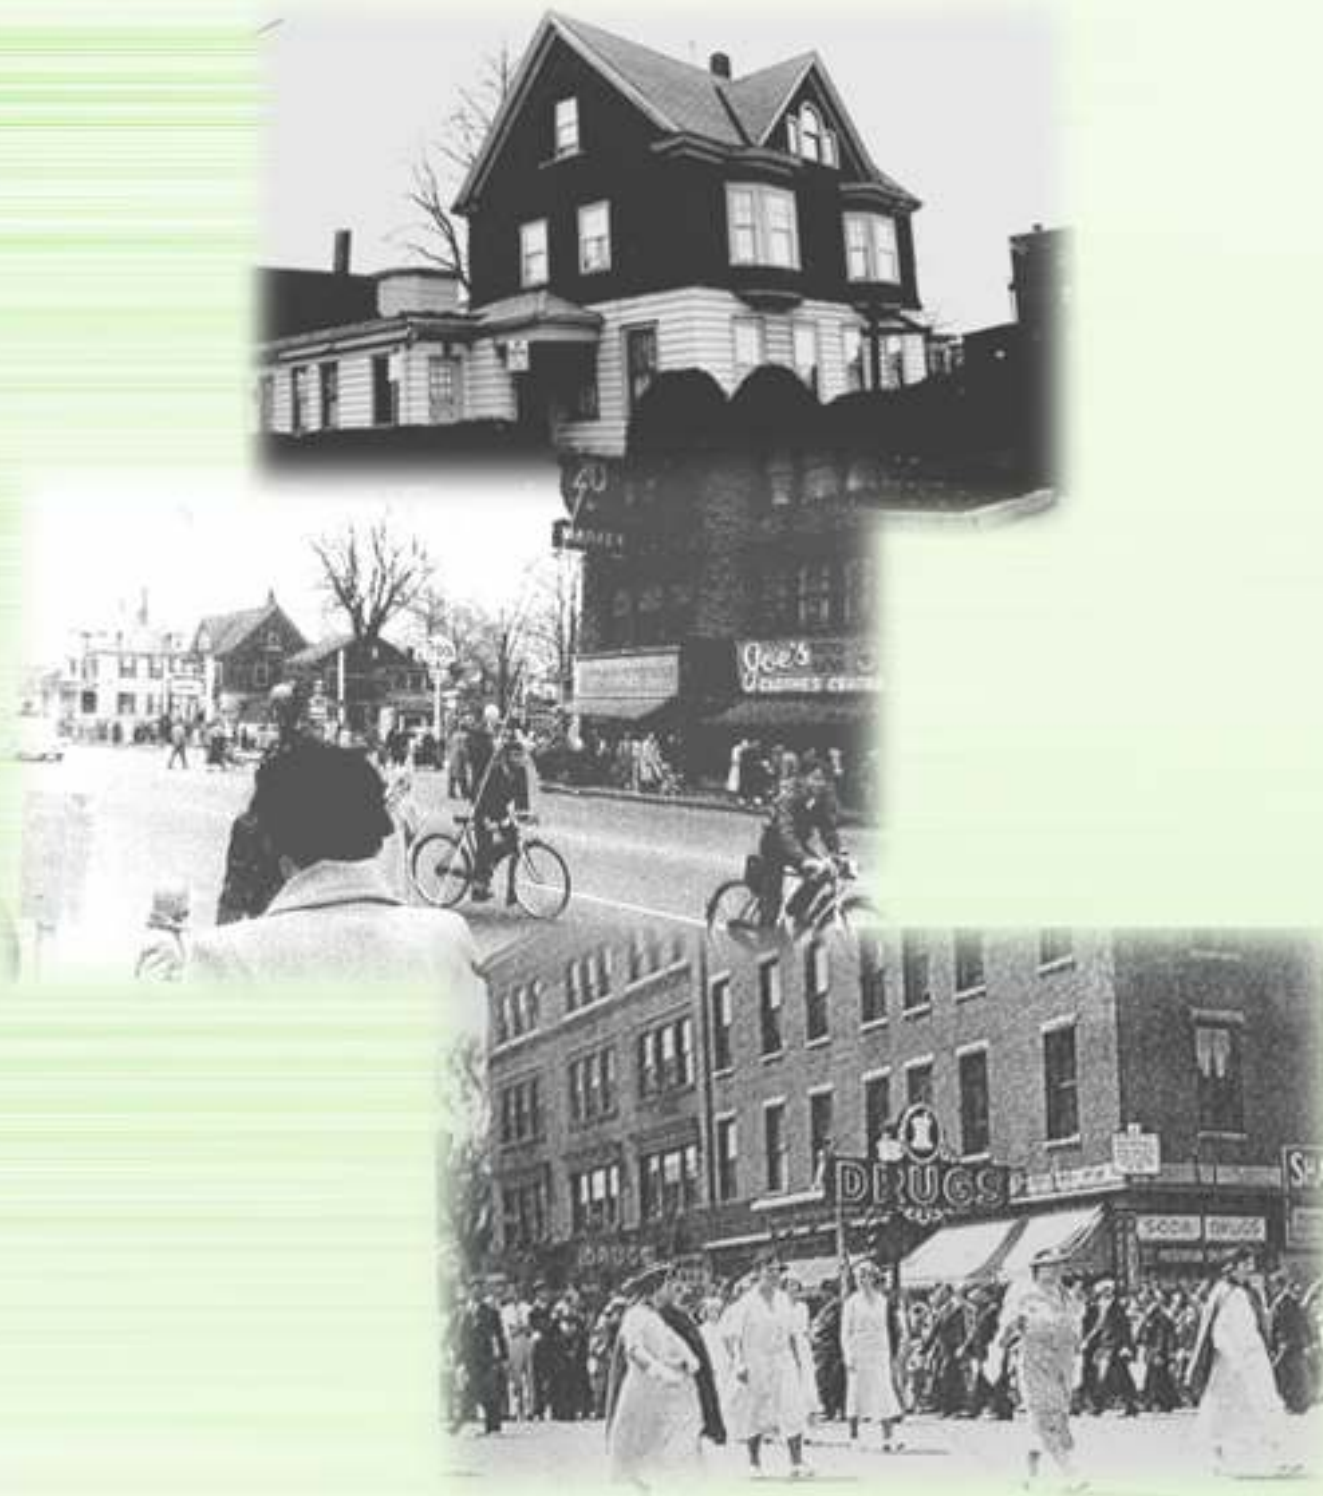
# HISTORIC VIEWS

*These historic photos demonstrate how to appropriately restore this block.*

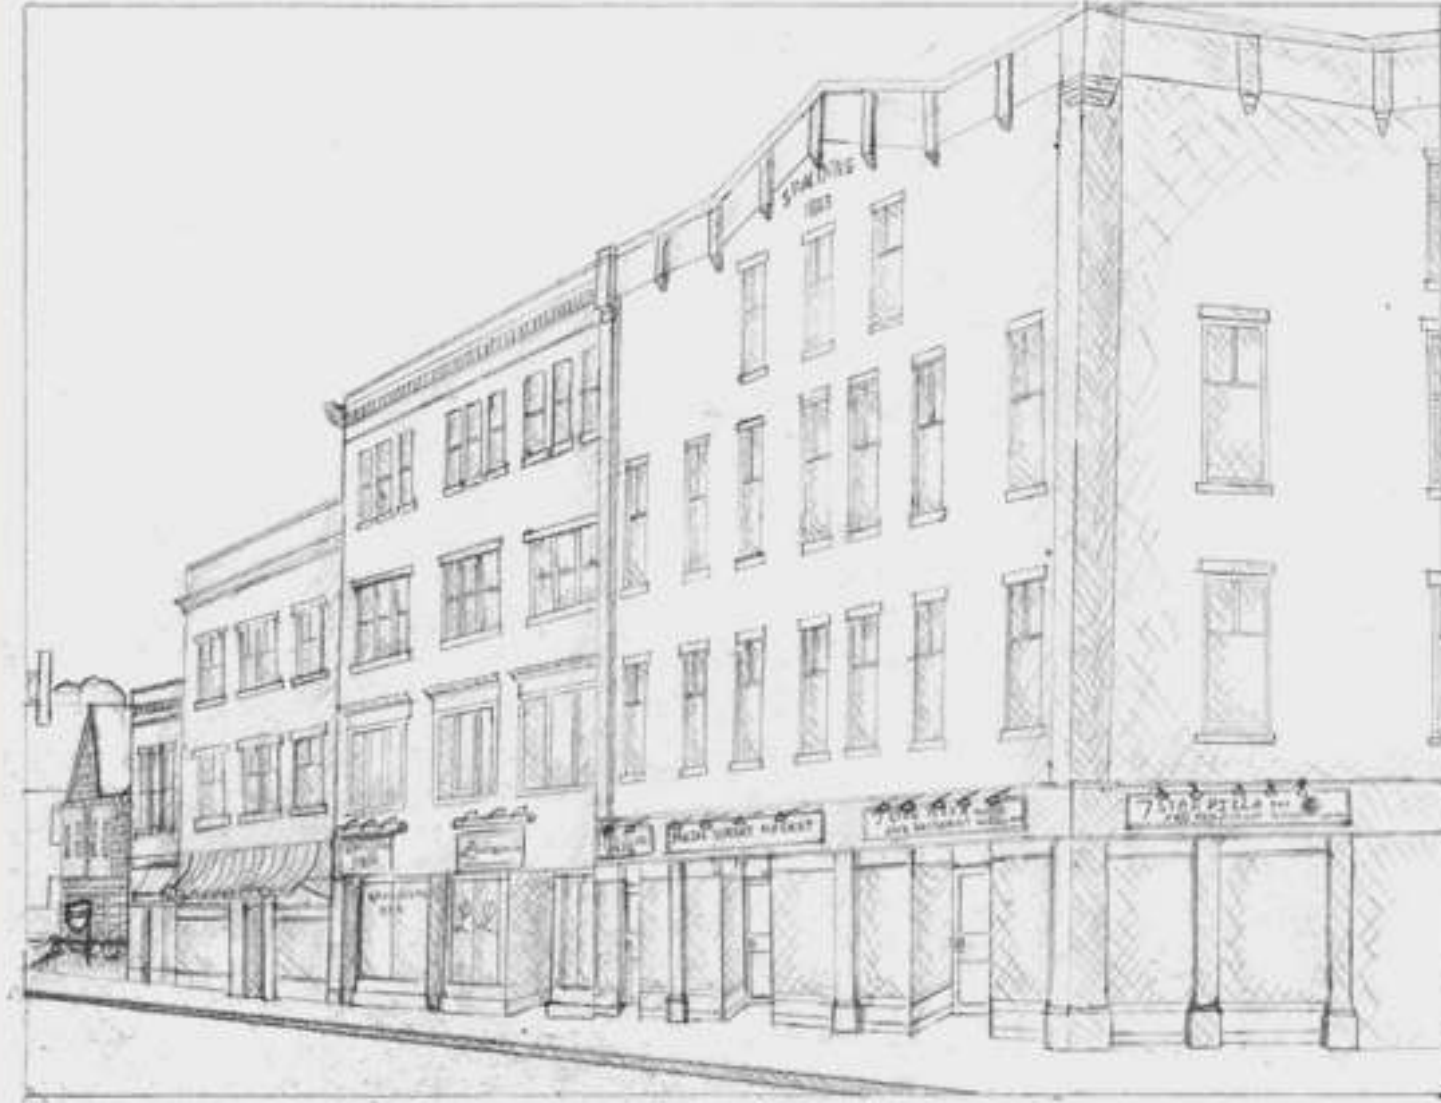
*This is a drawing of what the block could potentially look like after refurbishing the storefronts and adding infill buildings.*

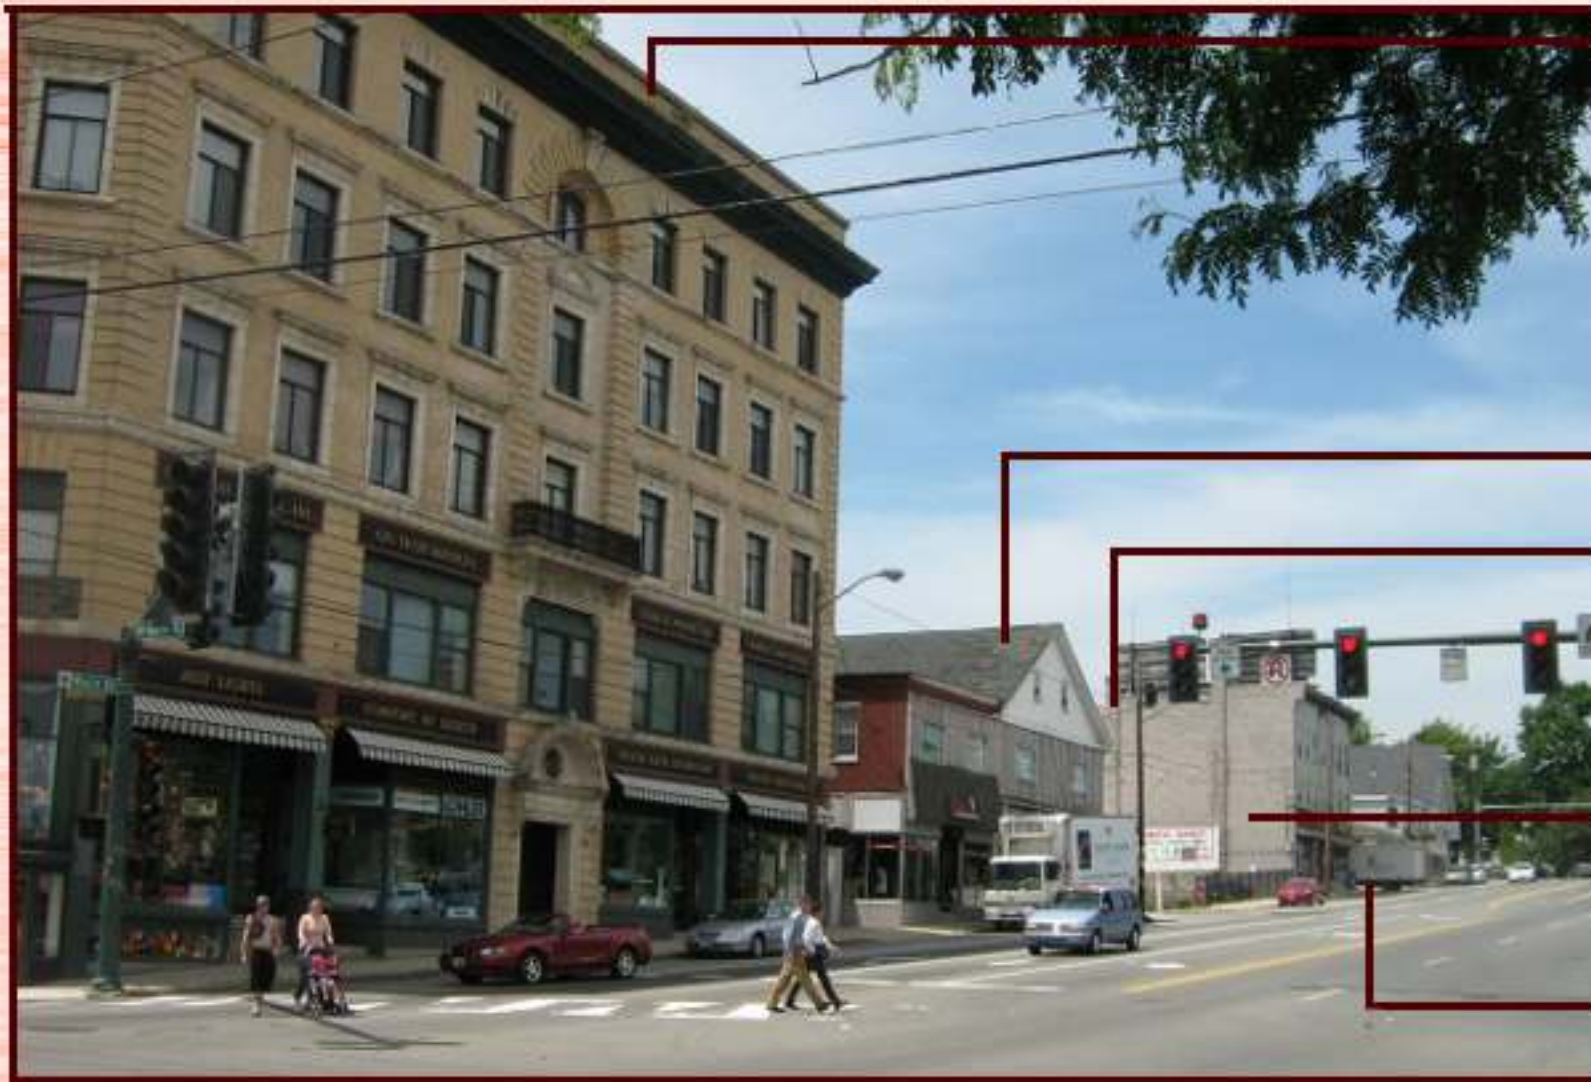
## 5-39 MAIN STREET

- Full length windows on all stories

- Remove added siding to reveal brickwork
- Windows with stone sill/stone lintel
- Entablature for surface mounted signs
- Restore storefront with wood and glass configuration on storefront
- Full windows with appropriate muntin

- Entablature for surface mounted sign
- Add ornate cornice
- Windows that are full length
- Restore façade from 1950s with white detailing for storefront

- Restore sills
- Bottom floor with more windows with white trim
- Clapboard siding

This block on Main Street has the potential to return to its historic roots to bring Railroad Square to life.

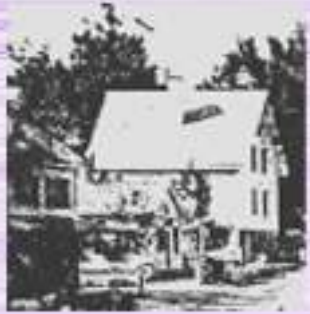
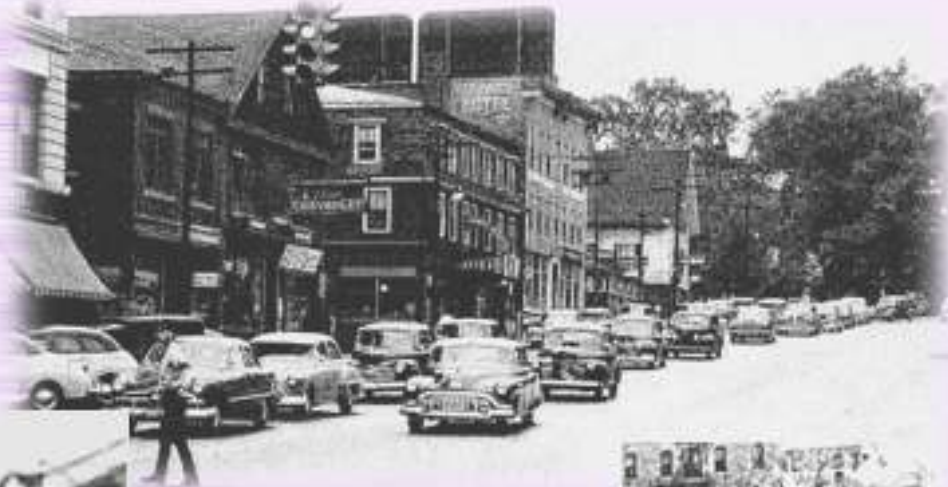
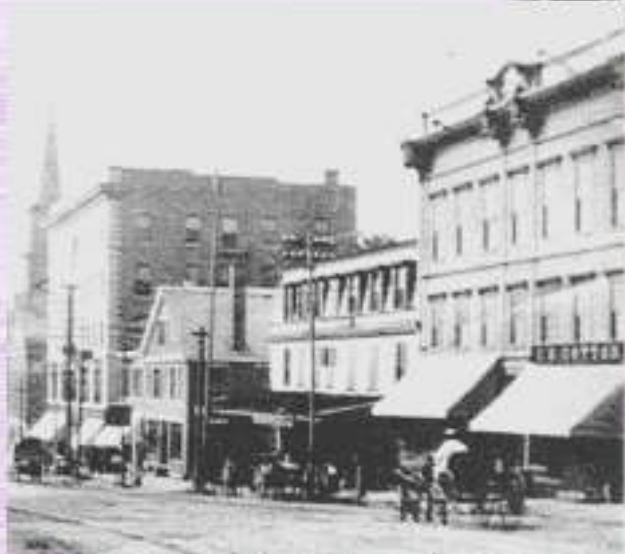
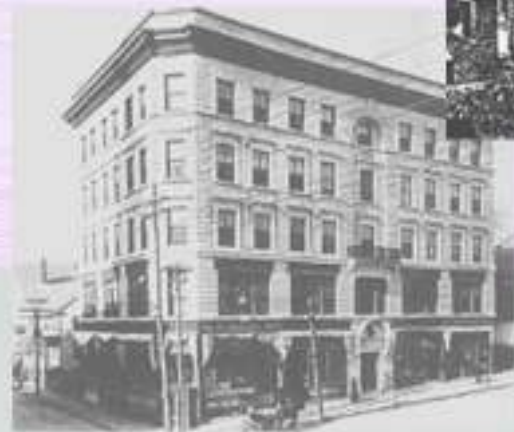
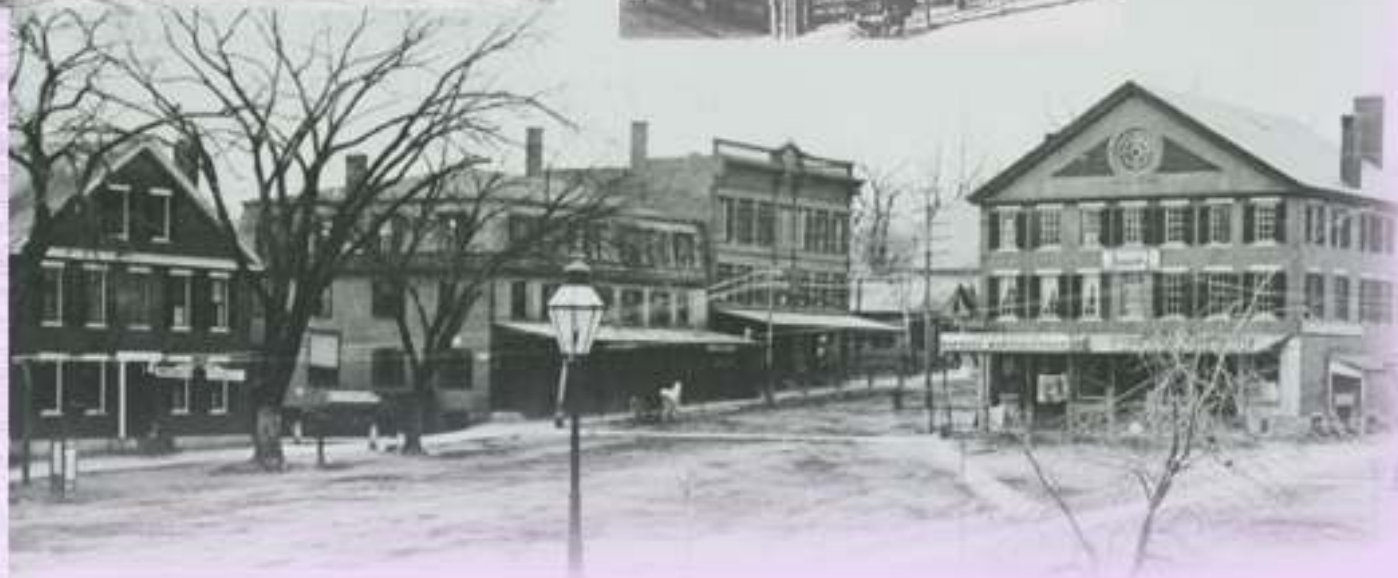
# HISTORIC VIEWS

The historic facades of this block appear below.

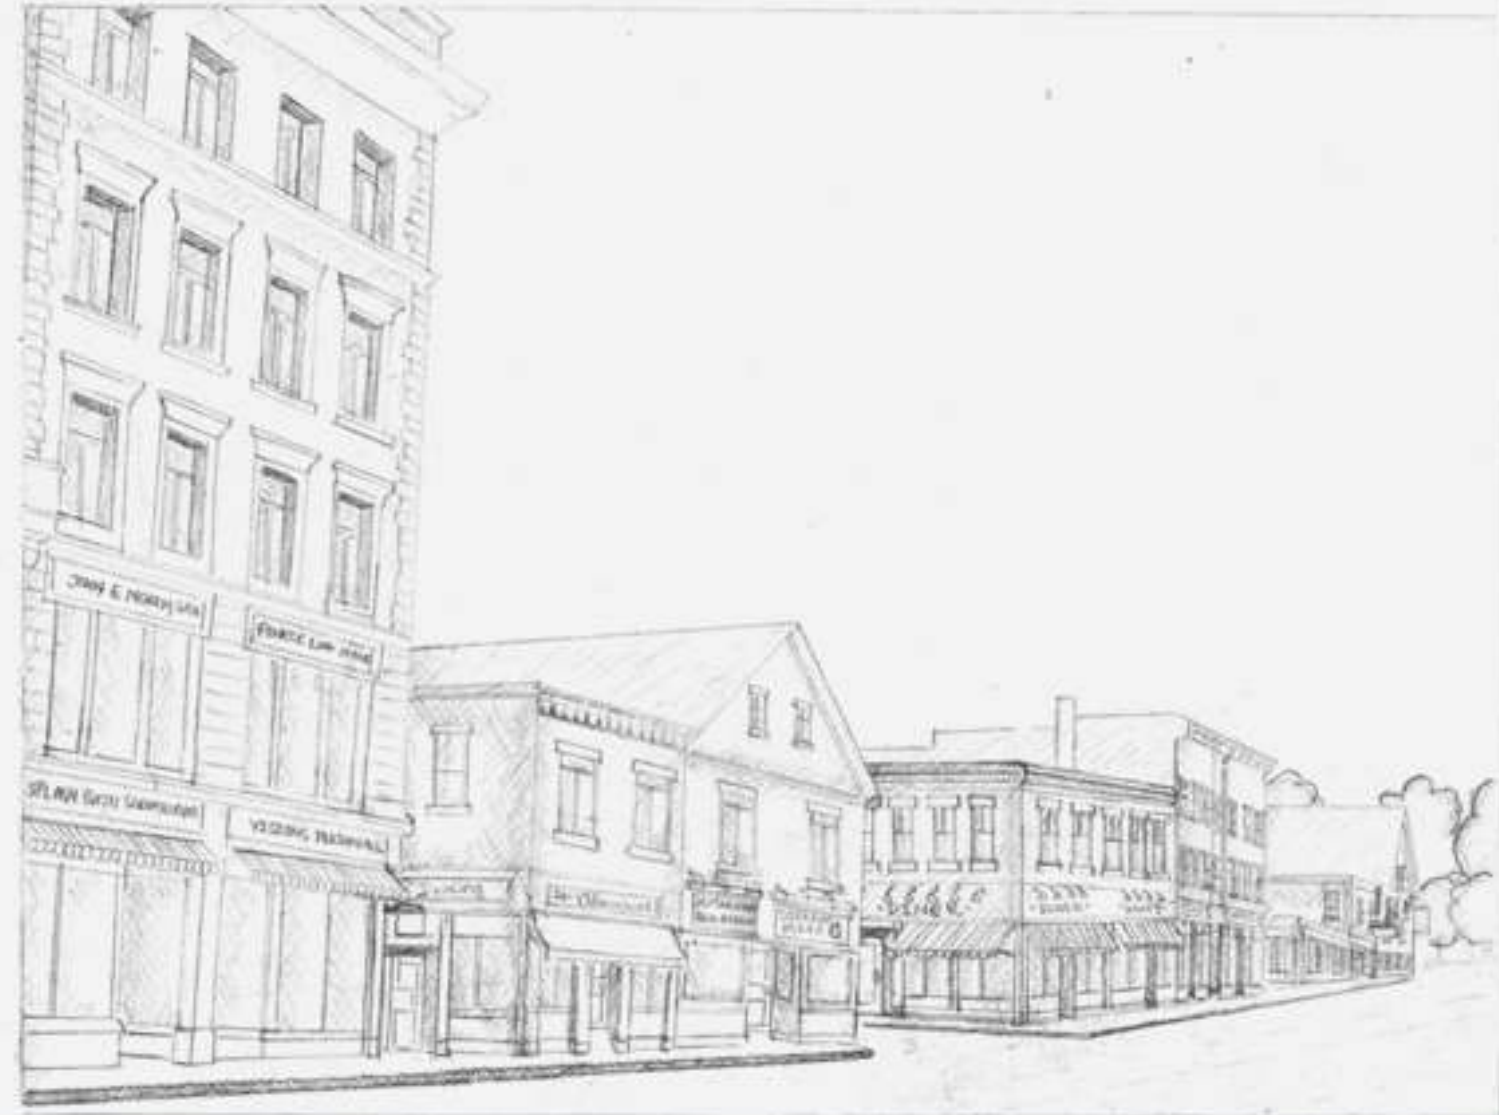
This is a view of the storefronts after restoring the facades and adding appropriate signage.

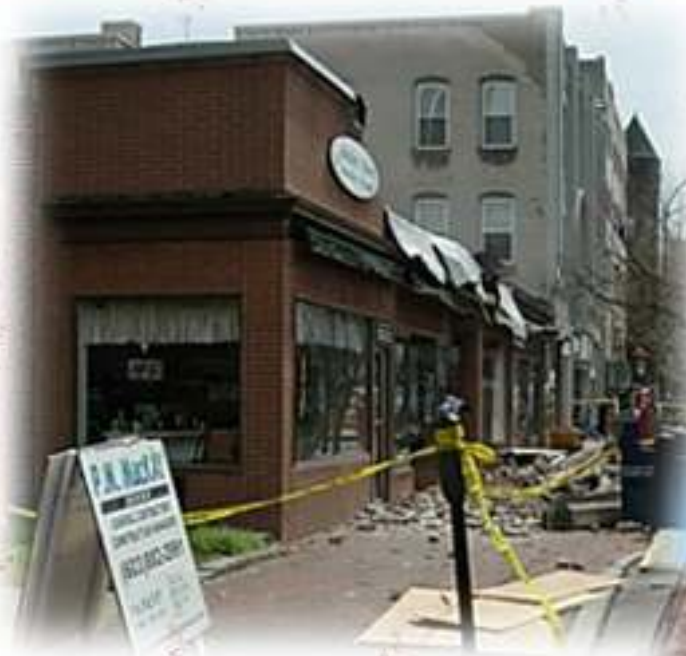
-Parapets and masonry should be repointed to prevent collapses. This is especially important when mortar is missing and water is accumulating in the joints. Mortar should duplicate the composition, color, texture and hardness of the original. Joints should not be overfilled.

-To clean masonry, gentle means should be used. Any missing bricks should be replaced by similar looking bricks.

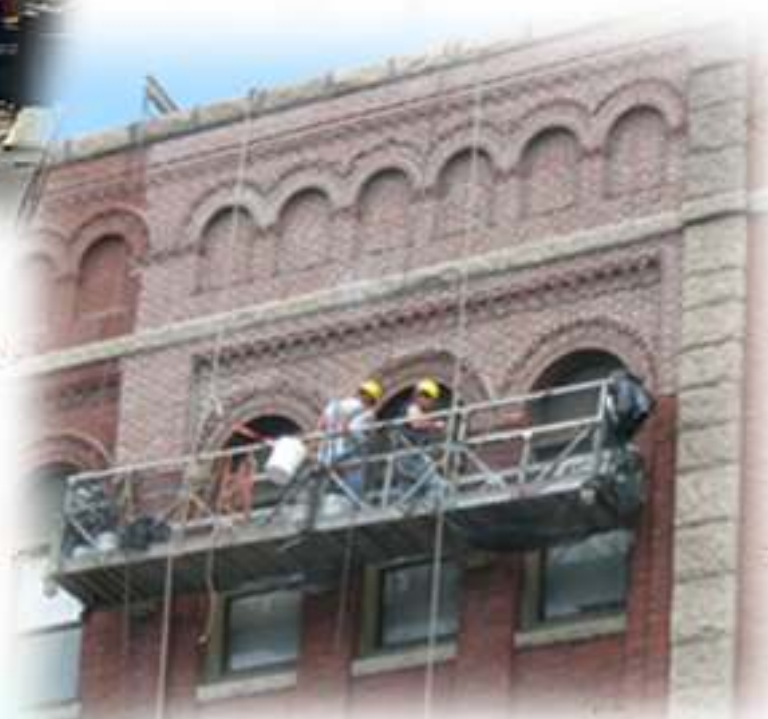
-Detailing should be maintained by cleaning and any rotted, rusted or broken sections should be replaced with materials that matches with the old.

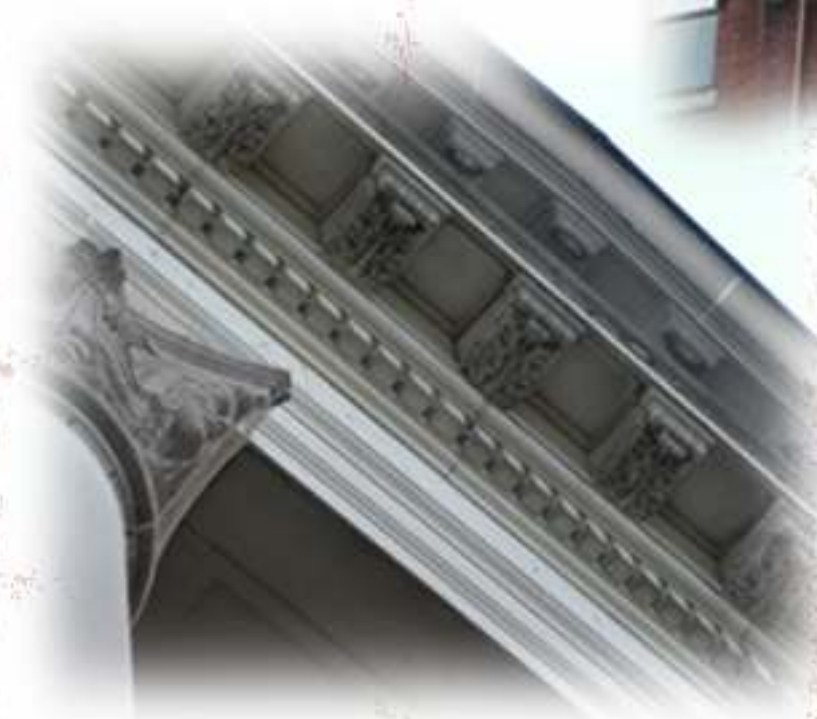
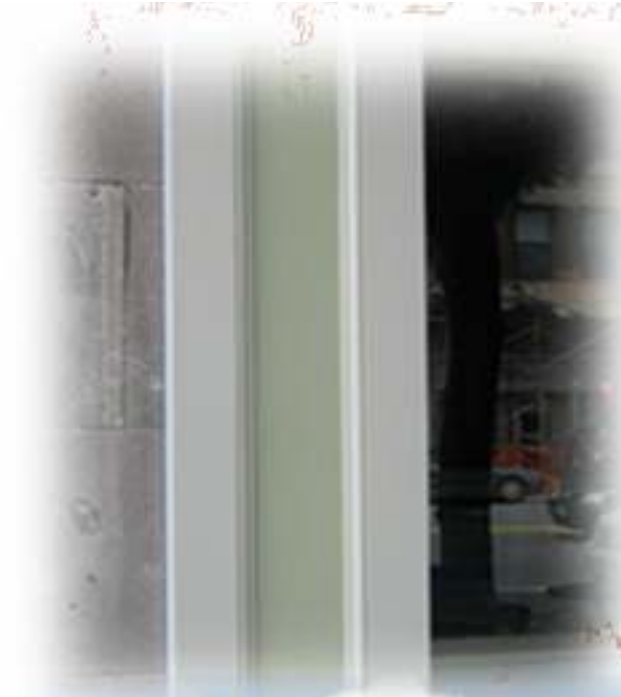
-Repainting facades that are starting to flake will help maintain the exterior. Using bright colors, such as neon yellows or other colors that do not fit with the character of the building is inappropriate.

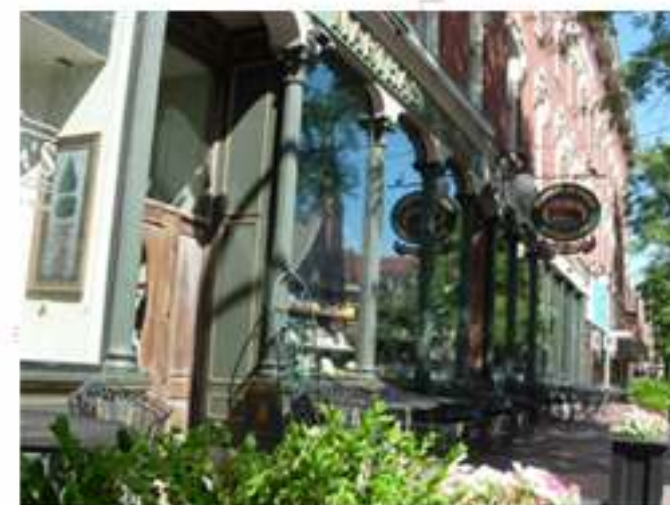
-Iron components on a storefront should have paint removed to restore the crispness to the details and may be repainted afterwards. All rust should be removed before repainting.

-If columns are missing, aluminum can be a successful substitute if the columns do not carry a great load.

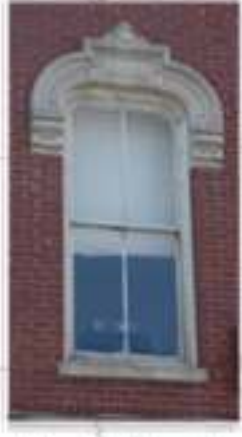
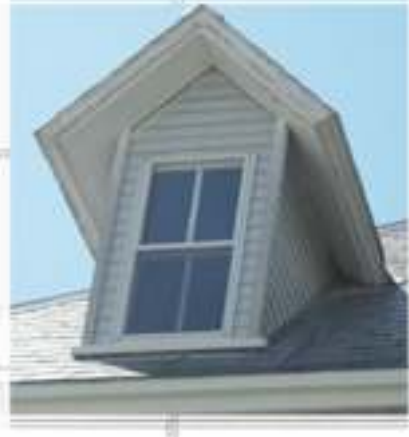
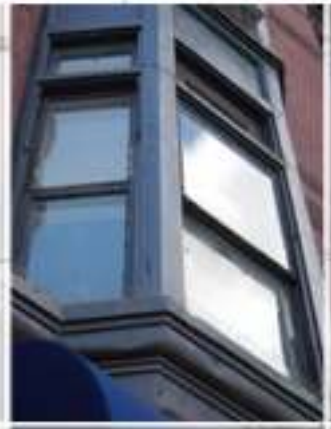
Appropriate windows on Main Street

Windows should be the full length as suggested by the original design. Care should be taken to maintain the sills and lintels.

Multi-paned windows are generally inappropriate for commercial buildings. Windows should be maintained with the original design, most of which are one or two panes.

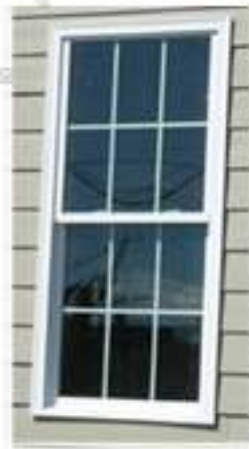
Inappropriate window for Main Street

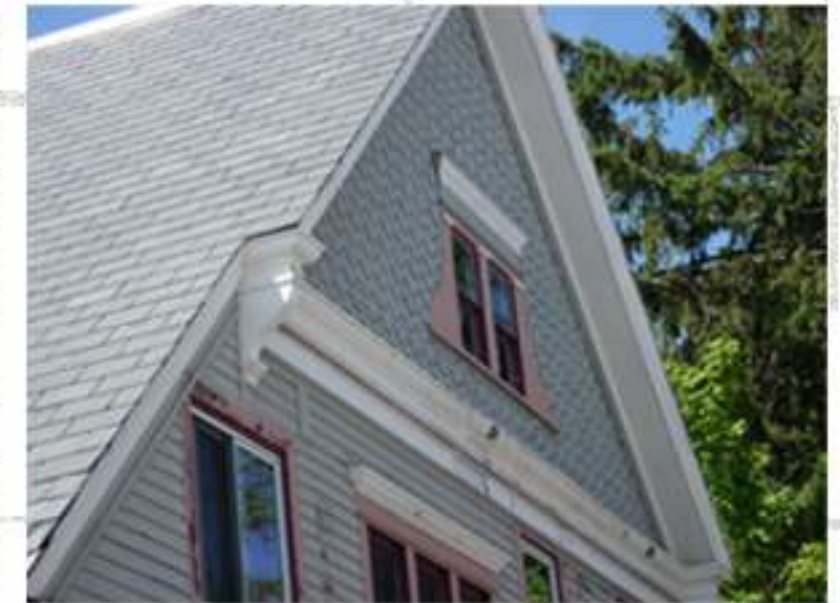
Although this house on Main Street should be painted white, the slate roof, detailing, and the shingles have been correctly maintained.

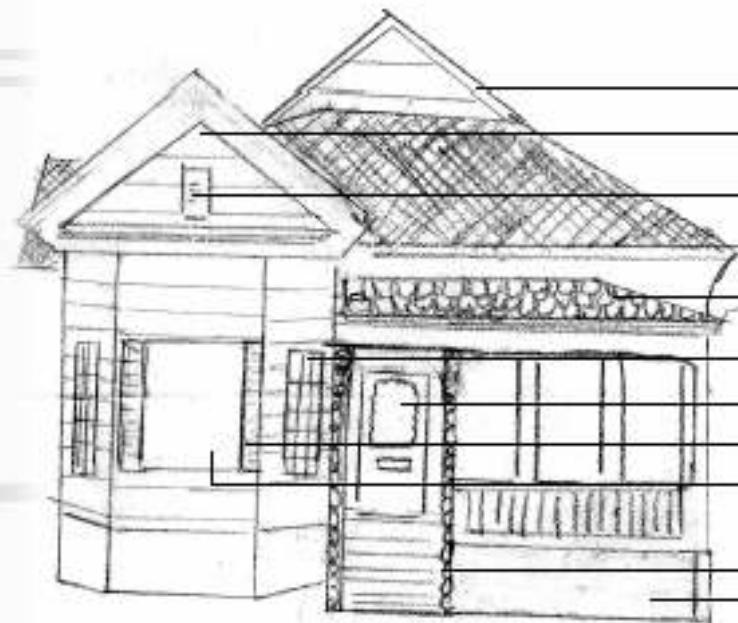
## Inappropriate Facade Renovation

- Removal of detailing
- Vinyl siding to replace clapboards
- Windows filled in
- Two different roofing materials
- Inappropriate multi-pane windows
- Incompatible door design
- Colonization by adding shutters
- New windows do not maintain the old style
- Iron railings that should be wood
- Foundation material not maintained

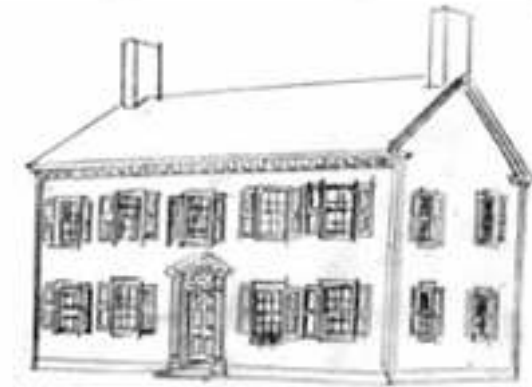
ADAM

The Adam, or Federal style was popular from 1780 to 1840. It often includes a semi-circular or elliptical fanlight over the front door, decorative crown, small entry porch, cornice with decorative moldings, dentils, double hung sashes with six panes, and windows aligned in symmetrical rows.

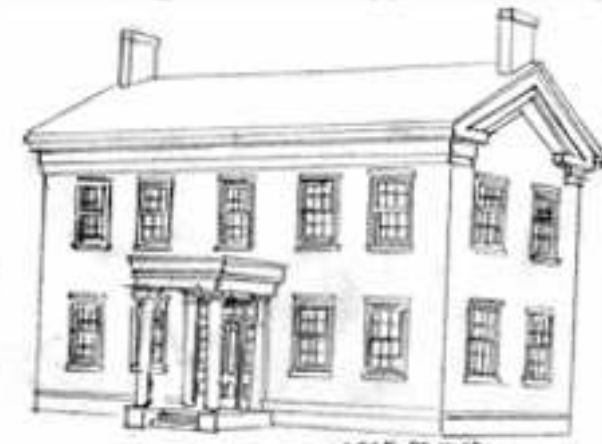
GREEK REVIVAL

The Greek Revival style dominated from 1830 to 1850. This style is often identified by the gabled or hipped roof with a low pitch, a cornice line which represents the classical entablature, elaborate entry, porches, and columns, often Doric in nature. The windows have six-pane glazing and the grating is typically of decorative Greek pattern.

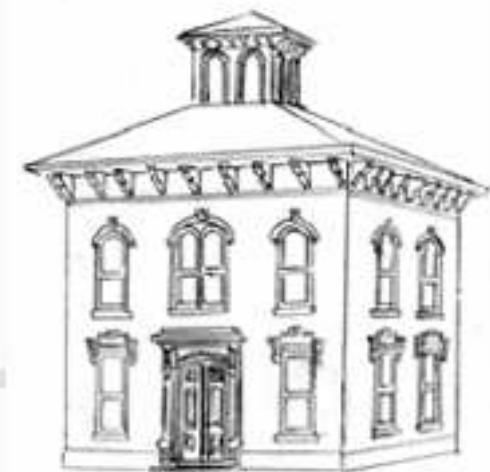
ITALIANATE

The Italianate style was built primarily between 1850 and 1875. Normally, Italianate houses are two or three stories, often have a square cupola or tower, have a low-pitched roof with overhanging eaves, and decorative brackets. There are also tall, narrow windows which are often arched and have elaborate crowns. Most have the inverted U shape. The sashes should have one or two pane glazing and windows typically are hooded, bracketed and/or pedimented, or framed.

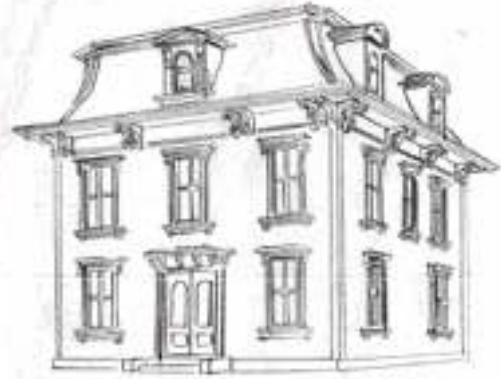
SECOND EMPIRE

Second Empire Houses typically have a mansard roof with dormer windows, molded cornices, and decorative brackets. These types of houses were typically built between 1860 and 1880. Windows may be similar to Italianate windows or could be unelaborated.

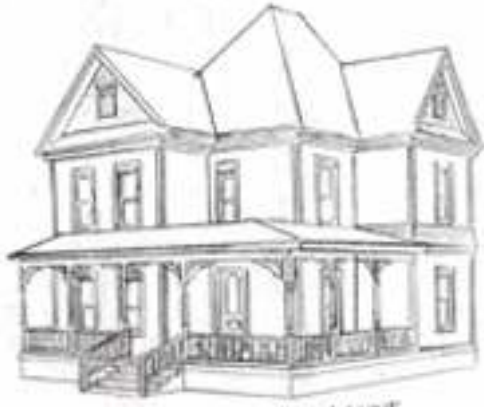
QUEEN ANNE

Queen Anne houses, typically built between 1880 and 1910. Some identifying features include a steeply pitched roof which is irregularly shaped, patterned shingles, cutaway bay windows, and an asymmetrical facade. Towers are a classic feature. Most have partial or full-width porches which are one story high. Doors and windows tend to be simple and sashes only have a single pane of glass. Roofs are very heavily accented and principal roof forms include spindlework, free classic, half timbered, and patterned masonry.

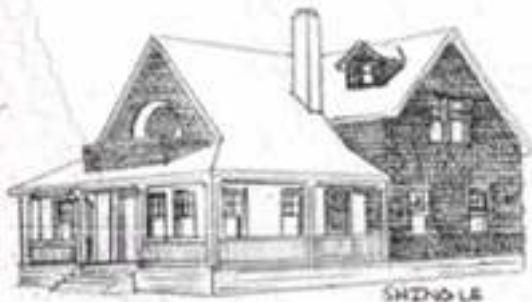
SHINGLE

Shingle style, identified by its wall cladding and roofing which is made of continuous wood shingles was popular during the years between 1880 and 1900. Many of these examples originally had wooden roofing, asymmetrical facades with steeply pitched roofs, intersecting gables, multi-level eaves, various dormers, and extensive porches. Typical elaborations include equal-sized sashes, recessed windows, Palladian windows, one or two-story bay windows, and strips of three or more windows.

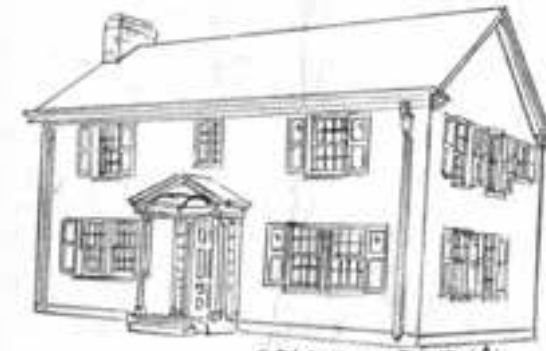
COLONIAL REVIVAL

This style, typically seen between 1880 and 1955 emphasizes an accentuated front door with decorative crown, pilasters, columns, doors with fanlights, facade which is very symmetrical, double-hung sash windows, multi-pane glazing, and windows in adjacent pairs. Revival entrances differed through the years they existed.

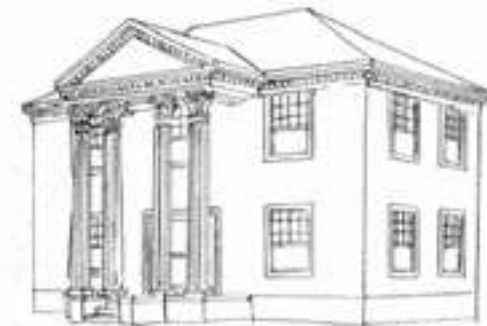
NEOCLASSICAL

Neoclassical existed from 1895-1950 and includes a full-height porch with a roof that is supported by classical columns. Most columns are typically Ionic or Corinthian. The facade is also symmetrically balanced. Unlike early classical revival and Greek revival, they often include side and wing porches, roof-line balustrades, exaggerated broken pediments, full-width raised platform porch, and a low balustrade around the platform porch.

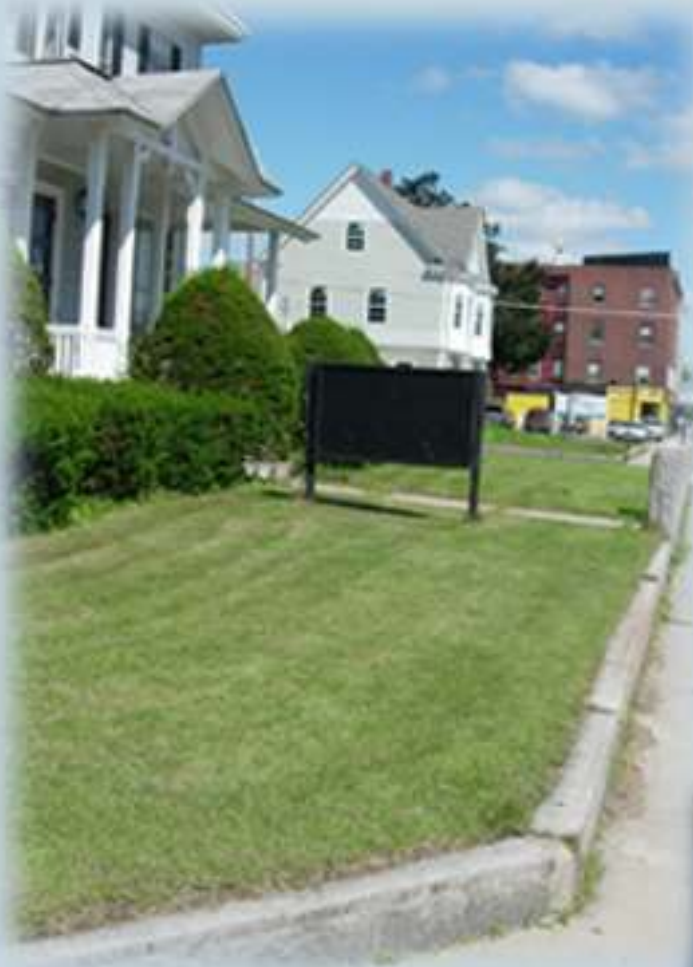
## Residential setback

Along Main Street, houses and residential buildings should be set back a small distance from the sidewalk. In other areas in the City which are almost completely residential, the setback is further from the sidewalk.

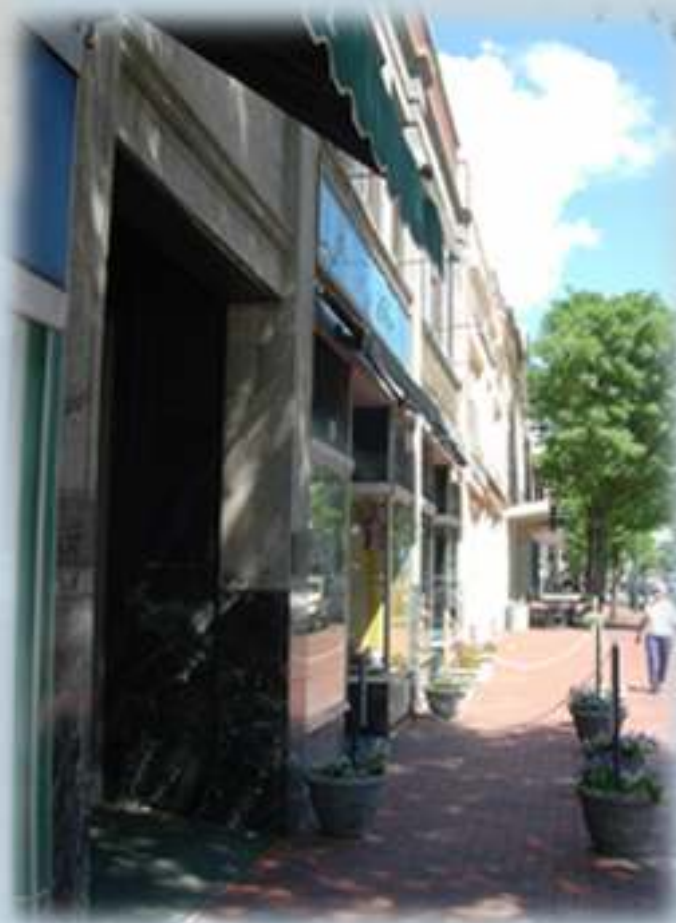
## Commercial setback

These buildings should be up at the sidewalk as is consistent with other buildings in the area.

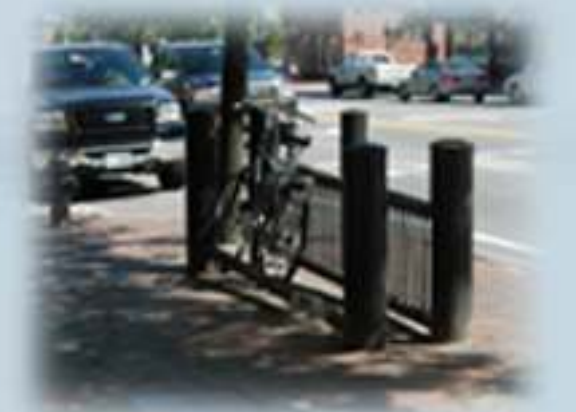
The South side of Main Street should be finished similarly to the rest of Downtown with brick, trees, and granite curbsides.

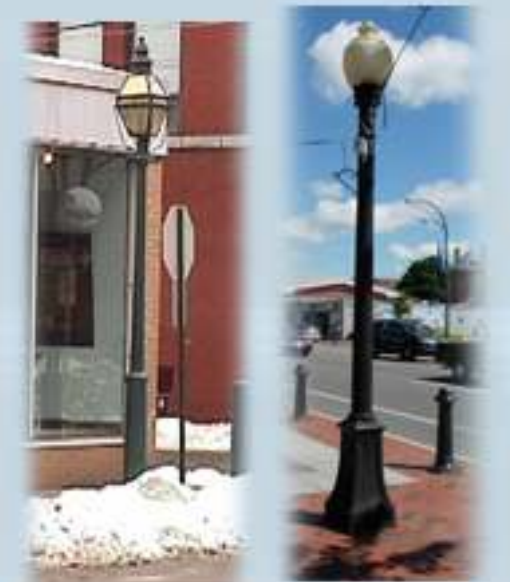
Lighting along Main Street should be appropriate with the character of Downtown. Power lines should be put underground and light posts should be uniform for the entire street.

Two appropriate types of lighting for Downtown

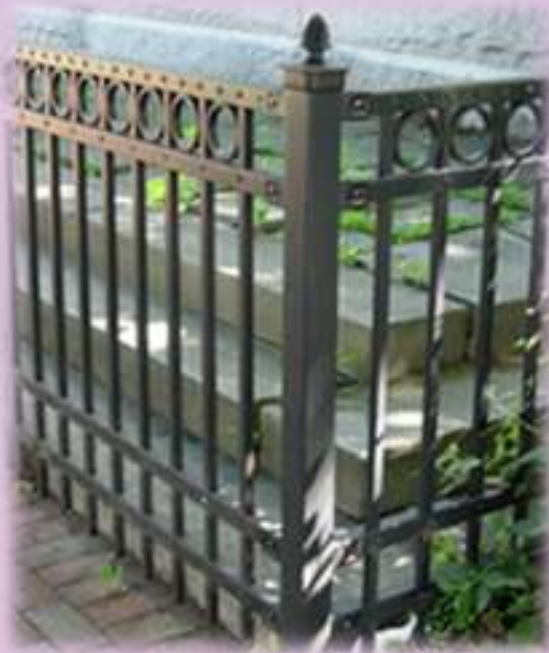
Appropriate iron fencing

Wrought iron fences are appropriate on Main Street and commercial areas. Discretion should be used in choosing the correct height based on nearby buildings or views. They should, however, not be highly stylized or used in residential areas.

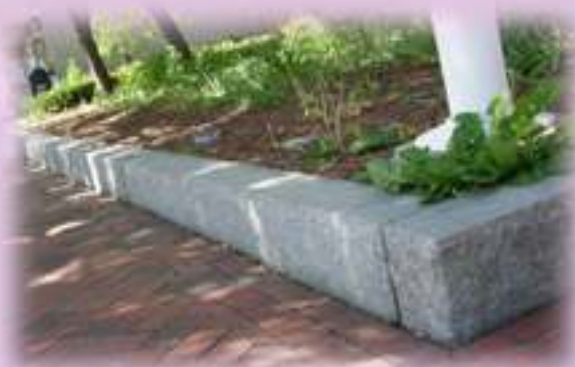
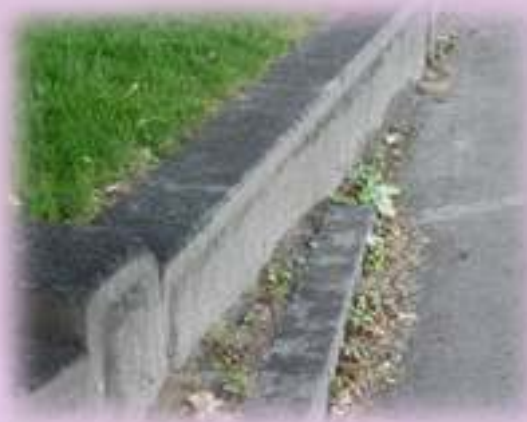
Brick, granite, and stone walls fit within the character of Downtown and also residential areas. Concrete block should be avoided.

Stone walls in Downtown

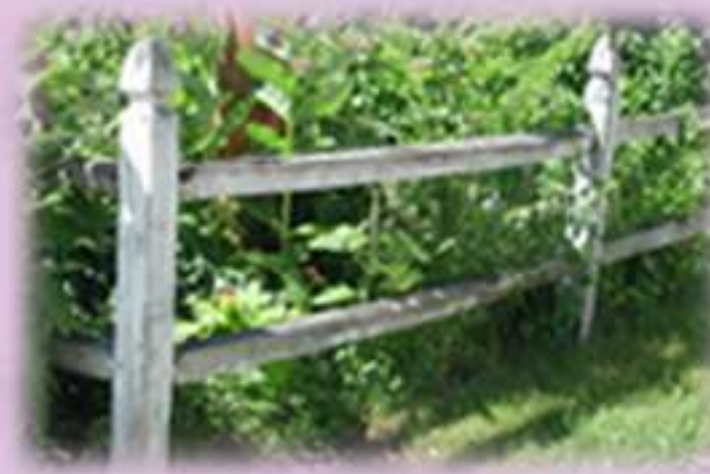
Inappropriate wood fencing

Wood fences are inappropriate on Main Street. Wood picket fences should be only used in residential areas and should stay at a maximum of 4 feet. Hedges can also be used in certain circumstances as fencing.

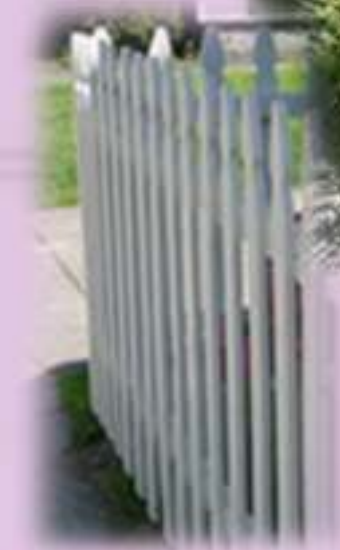
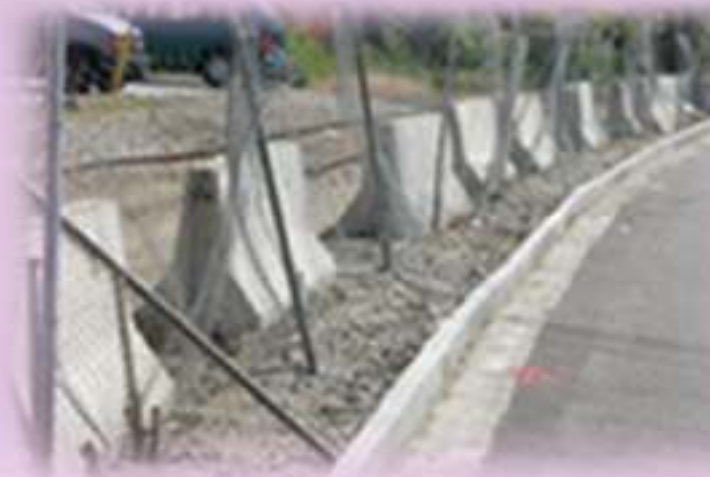
Fencing in residential areas

Chain link fences and jersey barriers are strongly discouraged and should be avoided.

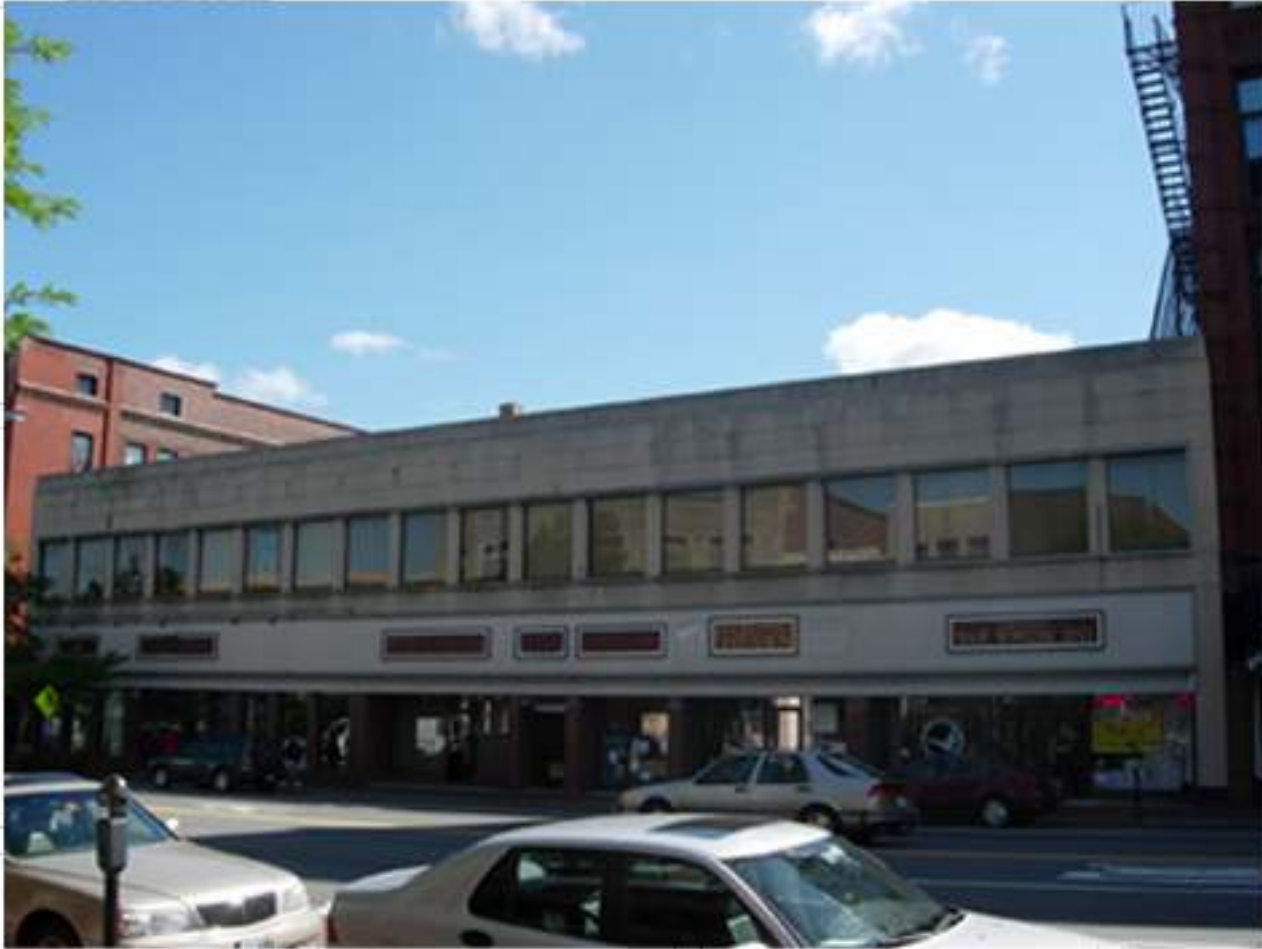
Inappropriate infill building

The structure of the infill building should match with that of neighboring buildings. For example, storefronts should match those on the block. It should fill the width of the site.
